## BOSTON REGION METROPOLITAN PLANNING ORGANIZATION

### MEMORANDUM

**DATE** December 6, 2012  
**TO** Boston Region Metropolitan Planning Organization  
**FROM** Mark Abbott and Bill Kuttner  
MPO Staff  
**RE** Safe Access to Transit for Pedestrians and Bicycles: Morton Street  
Commuter Rail Station

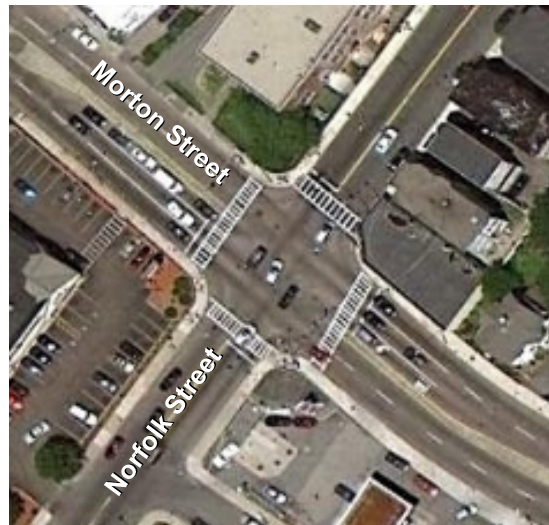
**Morton and Norfolk streets**

Traffic on Morton Street has left-turn signals in both directions. Norfolk Street from the south has a right-turn signal that shows green during the Morton Street left-turn phase. Right-on-red turns are not permitted.

Norfolk Street has one wide lane in each direction, allowing right-turn storage at the intersection and on-street parking further away. Morton Street has two travel lanes in each direction. A fifth, left-turn lane and a narrow, granite rumble-strip center divider consume any spare pavement on Morton Street at this intersection. Parking is allowed on Morton Street west of Norfolk Street, but not to the east, which is the direction of the commuter rail station. There are no bicycle-specific features.

While traffic speeds appeared to be within the speed limit, traffic could be characterized as “hurried,” with jackrabbit starts and tailgating. Vehicles were observed passing the through-traffic queue on the rumble strip in order to reach the short left-turn lane. After

the left-turn signal had turned red, some vehicles were observed turning left, apparently if the driver perceived what he or she considered a safe opportunity.

All legs of this intersection have ladder-style crosswalks, although they are faded. All of the sidewalks were in acceptable condition except on the northwest corner adjacent to the bus stop. The ramps were in acceptable physical condition. There were two on each corner, but only one had a detectable warning pad. There is a concern about the pedestrian signal buttons: on two corners there are large audible buttons, but on the other two corners there are old-style buttons. In addition, the audible buttons were not programmed to say "wait." Pushing a button results in a dedicated pedestrian phase, but there is no countdown feature. The pedestrian signal timing is 20 seconds, which is sufficient for the lengths of crossings at this intersection.

- Upgrade pedestrian signals so that they are consistent at all corners of the intersection, including being fully accessible and having countdown features. A uniform set of equipment and protocols for all pedestrian signal equipment along Morton Street will help pedestrians acclimate to the safe and approved alternatives for crossing of this busy corridor.
- Restripe the existing crosswalks.
- Install ADA-compliant detectable warning pads on all pedestrian curb-cut ramps.
- Stripe shared-lane markings (for bikes and motor vehicles) and install "Bicycles May Use Full Lane" (MUTCD R4-11) signs along Morton Street.

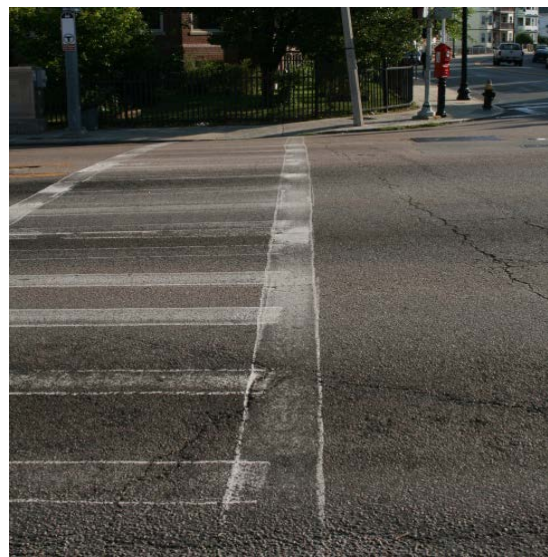
**Faded crosswalk at intersection of Morton and Norfolk streets**

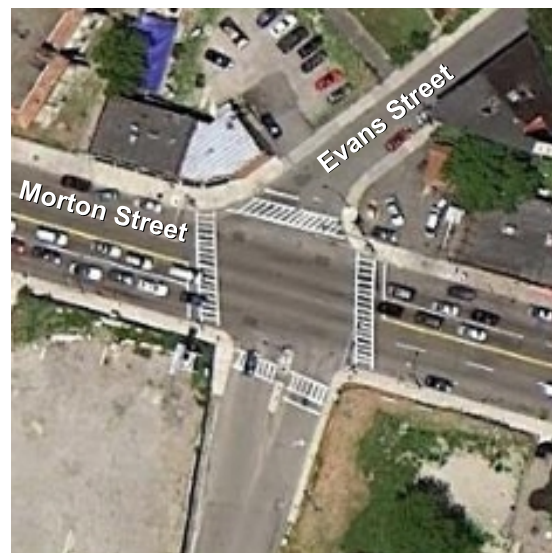
**Morton and Evans streets**

Immediately east of Norfolk Street, Morton Street becomes a bridge as it rises to cross the commuter rail line, and then descends to a signalized intersection with Evans Street as it approaches the bridge. Evans Street approaches Morton Street from the north and has two travel lanes in each direction. A wide commercial driveway approaches Morton Street from the south. The only traffic generator for the driveway at this time is a large plumbing and heating supplier, which could account for trucks and vans making up a large portion of the traffic. Accessible parking and a kiss-and-ride lane at the station will use this driveway when full two-track service resumes on the Fairmount Line. Also, there is a Dunkin' Donuts under construction, as well as a small development parcel, that will utilize this driveway.

During the site visit, traffic was observed to be light on both Evans Street and the driveway. The driveway entrance is wide and has a short median, which is helpful for channeling trucks into and out of the driveway. There are no left-turn signals, and right-on-red is permitted throughout this intersection. There are no bicycle-specific features.

Traffic on Morton Street is heavy and clearly "hurried," as observed during the site visit. Eastbound traffic appeared to possibly be exceeding the speed limit. Racing yellow lights and trying to beat on-coming traffic to make a left turn were observed to be commonplace.

Sidewalks, ramps, and crosswalks are in good condition, although one ramp has collected substantial debris. As at Norfolk Street, the pedestrian signals are problematic. Three corners have audible buttons, and one corner has an old-style button. The audible buttons tell when to walk, but are currently programmed for a quiet hum rather than the more intrusive chirp, despite having commercial uses on all four corners. Also, the pedestrian phase has been programmed to occur automatically every cycle, despite few pedestrians crossing. This loss of green time on Morton Street may exacerbate the practice of hurried driving. The pedestrian signal timing is 20 seconds, which is sufficient for the lengths of crossings at this intersection.

- Ensure that sidewalks and roadways are well maintained and clear of debris and excessive dirt.

- Upgrade pedestrian signals so that they are consistent with the pedestrian signals at Morton and Norfolk streets; include fully accessible and countdown features. A uniform set of equipment and protocols for all pedestrian signal equipment along Morton Street would help pedestrians acclimate to the safe and approved alternatives for crossing of this busy corridor.
- Sign and stripe five-foot bike lanes in both directions along Morton Street, from Evans Street to Norfolk Street. Although shared-lane markings would be required for the majority of Morton Street due to right-of-way constraints, bike lanes would be valuable along this section of Morton Street because of the reduced visibility, since traffic rises and descends crossing the Fairmount Line tracks.

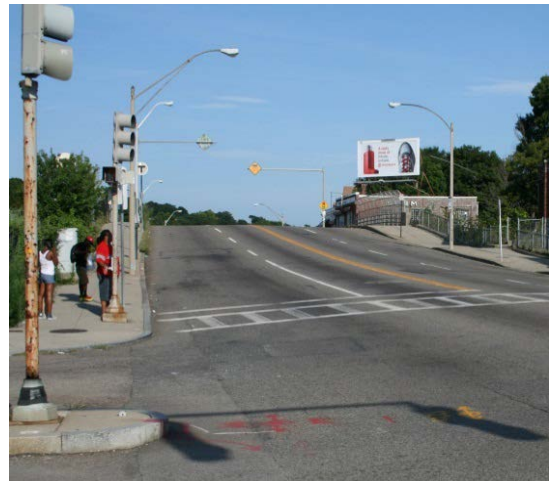
**Morton and Evans streets: Wide ROW to accommodate bike lanes**

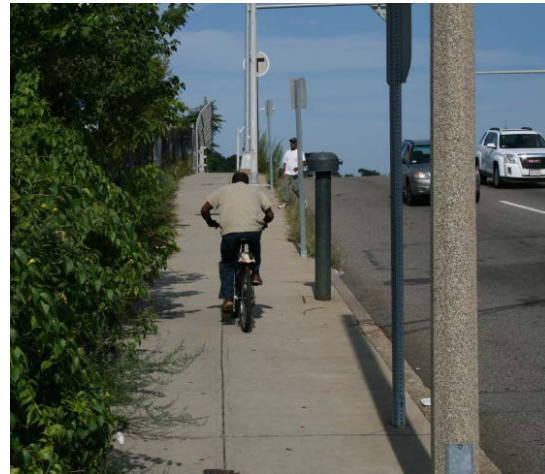
**Morton Street: Bicyclist riding on sidewalk**

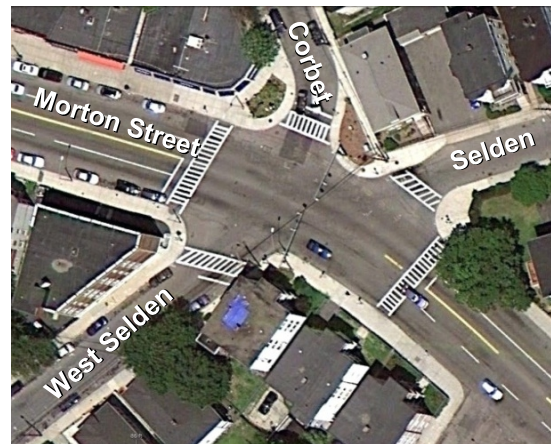
**Morton, Corbet, Selden, and West Selden streets**

About 1,800 vehicles approach on Morton Street during the AM peak hour and about 9% turn onto the side streets, evenly split between left and right turns. Of the 265 vehicles approaching from the side streets, over 60% turn onto Morton Street. Frequent conflicts result from side street traffic making left turns, exacerbated by the occasional

vehicle from Corbet Street making a hard left turn to Selden Street. There is significant truck traffic on Morton Street, but no trucks were observed on the side streets. Rights-on-reds are permitted and there are no specific bicycle features.

Morton Street has four travel lanes and on-street parking on both sides of the street. During the site visit, traffic appeared to be within the speed limit, but seemed hurried with both jackrabbit starts and tailgating observed.

Sidewalks, ramps, and crosswalks are in good condition. As is the case in the other two signalized intersection, the five corners provide a mix of audible and old-style crossing buttons. Pushing a button results in a dedicated pedestrian phase, but there is no countdown feature. The pedestrian signal timing is 21 seconds, which is sufficient for the lengths of crossings at this intersection.

- Upgrade pedestrian signals so that they are consistent with the pedestrian signals at Morton and Norfolk streets, including with fully accessible and countdown features. A uniform set of equipment and protocols for all pedestrian signal equipment along Morton Street will help pedestrians acclimate to the safe and approved alternatives for crossing of this busy corridor.

- Stripe shared-lane markings (for bikes and motor vehicles) and install “Bicycles May Use Full Lane” (MUTCD R4-11) signs. The width of Morton Street to the west and east of this intersection, and the presence of on-street parking, suggests that shared-lane markings would be the appropriate method to indicate and encourage the use of Morton Street by bicycles. Given the size of the intersection, the shared-lane markings should continue through the intersection as bicycle priority lanes (picture, right).

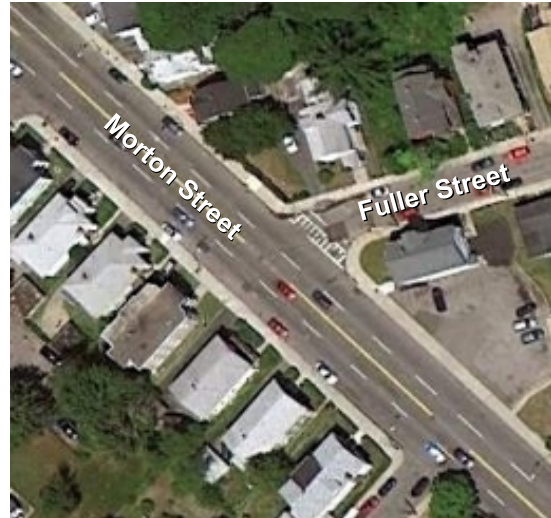
**Morton and Fuller streets**

The heavy traffic on Morton Street at this location moves rapidly here at roughly the midpoint between two major intersections. While parking is permitted on Morton Street, few vehicles were parked in the vicinity, effectively widening the right travel lane and inviting higher speeds. Morton Street traffic included a number of trucks, and there are no specific bicycle facilities.

The sidewalks are wide and in good condition. The ramps are also in good condition, although the pavement adjacent to the concrete ramp on one corner has subsided more than an inch. There is a crosswalk painted across Fuller Street, but none across Morton Street.

- Stripe shared-lane markings (for bikes and motor vehicles) and install “Bicycles May Use Full Lane” (MUTCD R4-11) signs along Morton Street east of Selden Street. The presence of on-street parking that is not fully utilized is especially beneficial to cyclists. Shared-lane markings striped along the ample right lane in this section may calm traffic. The paucity of parked cars would also afford cyclists more room and allow them to focus their vigilance on a limited amount of parked cars and parking activity.
- Eliminate the existing bus stops at Owen Street and replace with new bus stops at the junction of Morton Street and Gallivan Boulevard.

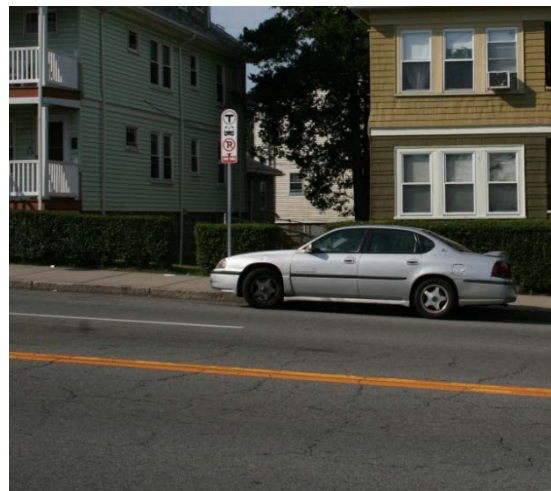
The most dangerous circumstance at this intersection is the presence of a pair of MBTA bus stops on each side of Morton Street at Owen Street, 140 feet east of Fuller Street and also lacking a marked crosswalk over Morton Street. While use of an unmarked crosswalk is permitted, this would be a less-safe option for crossing Morton Street, especially if pedestrians are rushing to catch an approaching bus. Pedestrian traffic in this area, transit related and otherwise, would probably not warrant the installation of a marked crosswalk.

**Morton and Fuller streets:  
Midblock bus stop with no  
crosswalk**

Bus stops are not currently practical at this location because of the requirement that eastbound buses merge left to continue their routes on Gallivan Boulevard. However, a recently completed Intersection Alternatives Design Report (MassDOT, June, 2012) proposes improved traffic channels and crosswalks at the junction of Morton Street and Gallivan Boulevard. Incorporating new MBTA bus stops into the final design is recommended as a high priority for both safety and user benefits.

East of Selden Street, bus stops for routes 21 and 26 are spaced an average of 575 feet apart. Since buses cannot currently stop at the junction of Morton Street and Gallivan Boulevard, the closest stops are at the remote and problematic Owen Street to the west, and at Wilmington Avenue to the east. Replacing the Owen Street and Wilmington Avenue bus stops with one stop at the junction of Morton Street and Gallivan Boulevard will speed bus service through the net elimination of one stop, and add service at an important neighborhood nexus. With this modification, the average stop spacing would be 863 feet, and a preliminary analysis suggests that the maximum spacing would be about 955 feet, which falls within MBTA’s bus stop spacing guidelines.
