MEMORANDUM

DATE December 6, 2012
TO Boston Region Metropolitan Planning Organization
FROM Mark Abbott, Christine Bettin, and Bill Kuttner
MPO Staff
RE Safe Access to Transit for Pedestrians and Bicycles: Oak Grove Station

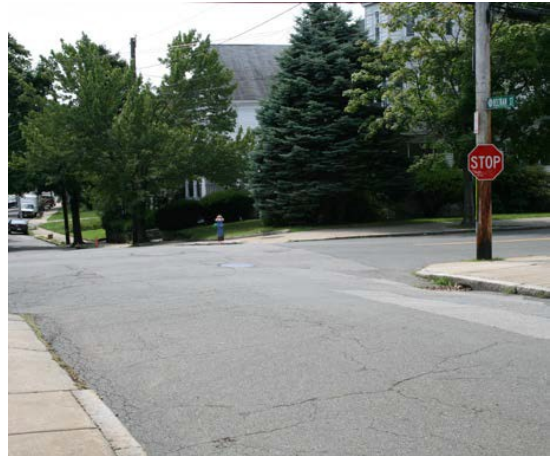
Beltran Street: No stop bars or crosswalks

- Stripe highly visible ladder-style crosswalks on all legs of this intersection. Ladder crosswalks are more visible than simple parallel lines, especially at night or in low light conditions.
- Install ADA-compliant detectable warning pads on all pedestrian curb-cut ramps.
- Stripe stop bars on Beltran Street in advance of the stop signs. Bicycle Improvements

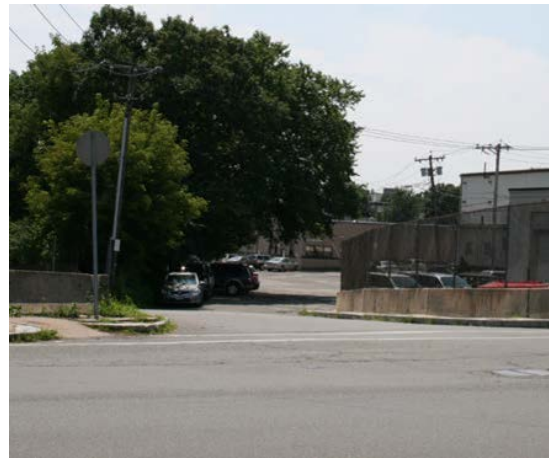
Winter Street: Missing pedestrian ramp at SW corner

Three approaches to this intersection have painted crosswalks. There is no crosswalk across the west leg of this intersection. There is a painted crosswalk with a Yield to Pedestrians sign on a stanchion across Winter Street on the east side of the intersection.

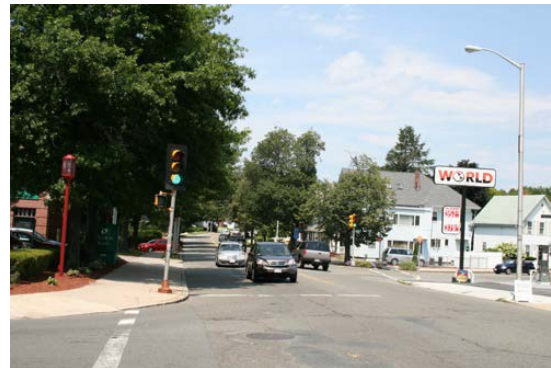
Main Street, NB: Offset “T” intersection

The sidewalks are wide; some are old and some are newly built. One corner lacks a pedestrian curb-cut ramp, requiring the use of a nearby driveway. The sidewalks along the 160-foot offset section have curb cuts that allow vehicle access to a bank branch on the west and a gas station on the east side of the intersection.

- Restripe ladder-style crosswalks at all legs of this intersection.
- Install ADA-compliant detectable warning pads on all pedestrian curb-cut ramps.
- Repair the pedestrian signal heads on the northwest and southwest corners of Main Street and Winter Street.
- Repair the pedestrian signal push button on the northeast corner of Main Street and Forest Street.
