MEMORANDUM

DATE December 6, 2012
TO Boston Region Metropolitan Planning Organization
FROM Mark Abbott, Christine Bettin, and Bill Kuttner
MPO Staff
RE Safe Access to Transit for Pedestrians and Bicycles: Oak Grove Station

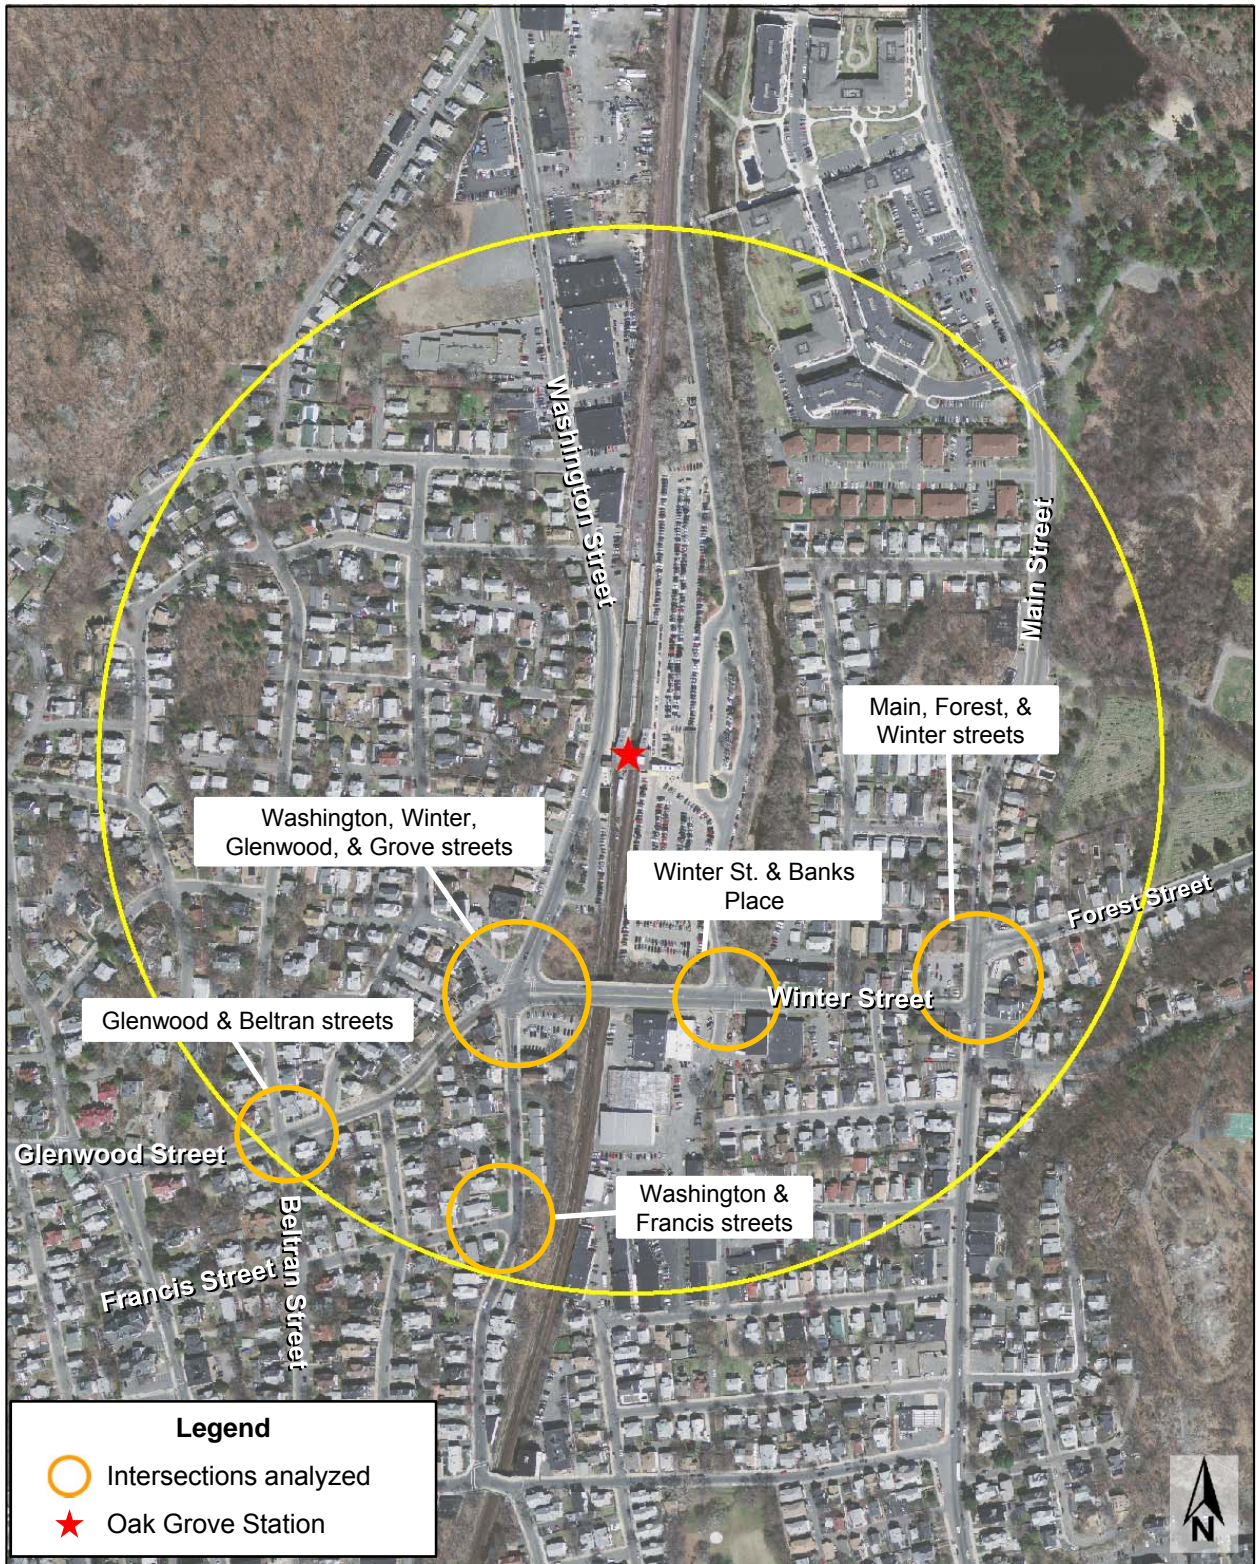
FIGURE 2
Intersections Analyzed
within One-Half Mile of Oak Grove Station

Five of those six locations, excluding Glen Rock Road at Washington Street, were selected for further analysis (see Figure 2). The five intersections are:

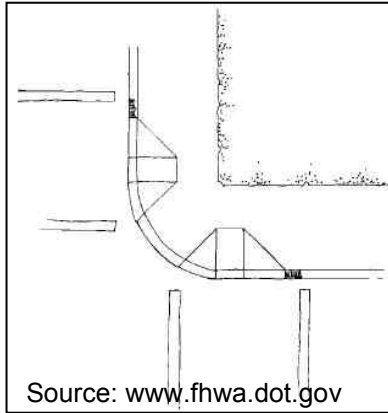
In a few locations, the sidewalks do not have a curb-cut wheelchair ramp at crosswalks. Also at some locations, sidewalks have diagonal (apex) curb ramps, where only one ramp is provided at a street corner; these ramps typically are not aligned with the marked crosswalks. Diagonal curb ramps are the predominant type used in the study areas; however, this type of curb ramp is not recommended by current Federal Highway Administration best-practices guidelines. Instead, street corners should have two curb ramps, one aligned with one street's crosswalk and the other aligned with the other

street's crosswalk (see the diagram at the left). For additional safety, the bottom of the ramps should have a detectable warning strip.
